SERVICE BULLETIN

Periodic inspection of the float buoyancy for ROTAX® Engine Type 912 and 914 (Series)

ATA System: 73-00-00 Fuel system

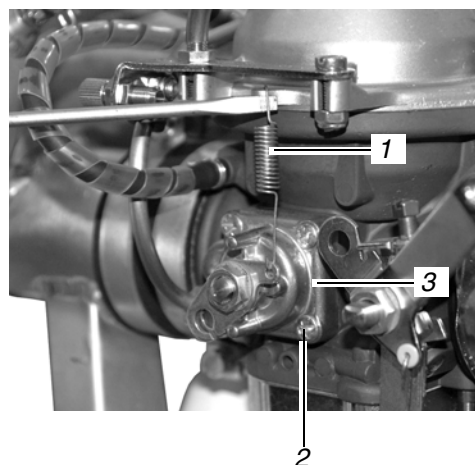
Fig. 1

Step	Procedure
1	Bring the float chamber to horizontal position (level the aircraft, if necessary).
2	Let the engine idle for approx. 1-2 minutes. NOTE: Switch OFF the electric fuel pump (at 912 Series).
3	Remove the return spring (1).
4	Remove 4 Philips head screws (2). Remove rotary valve housing (3) with the gasket.
5	Remove the air vent line (4). Installed steel line must not be removed.

- 1 Return spring
- 2 Philips head screw M4x14
- 3 Rotary valve housing
- 4 Air vent line

In the following inspection the float chamber will be filled up to the venting bore and the required volume determined. The volume given indicates the resulting fuel level and provides information on the float status or buoyancy.

See [Fig. 1](#).

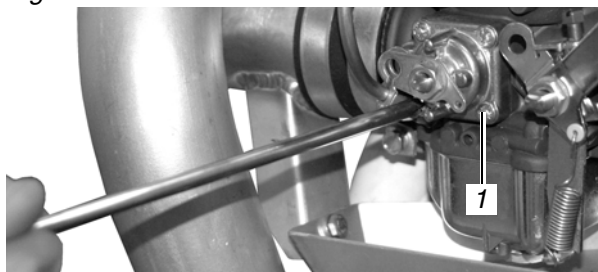
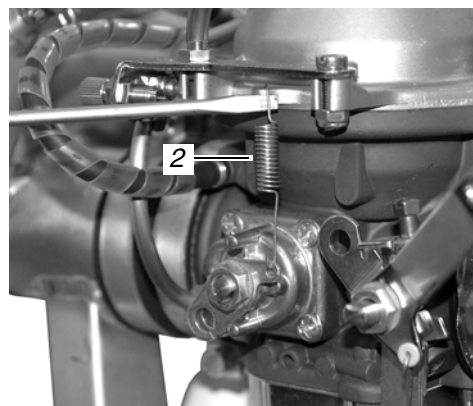
Fig. 3

Step	Procedure
1	Install the venting line.
2	Install rotary valve with new gasket.
3	Secure first 2 threads of the Philips head screw 4x14 (1) with LOCTITE 243.
4	Install the return spring (2).

1 Philips head screw 4x14
2 Return spring

See Fig. 3.
